Coolant Leak from ISS External Active Thermal Control System (EATCS) – An Examination of Most Probable

Darnell T. Cowan¹, Timothy A. Bond²

NASA Lyndon B. Johnson Space Center, Houston, TX, 77058

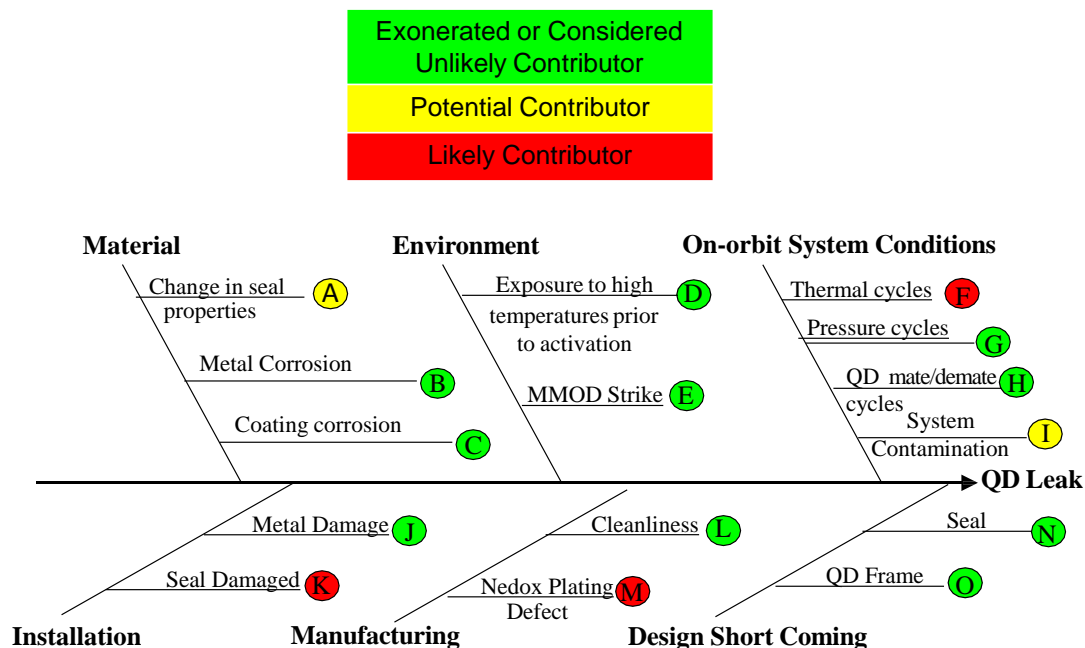
Figure 3. Fishbone Diagram of Potential Contributors to the QD leak

Bones B through E, G through H, J, L, and M through N shown in figure 3 were exonerated or considered unlikely a contributor to the QD leak. The QDs are made of 15-5 stainless steel and Inconel 718 with thick walls. Any cracks to the material because of corrosion, installation issues or collisions with Micrometeoroid and Orbital Debris (MMOD)³ could cause a leak. However, this was not observed from the imagery inspections or chemical evaluations. Prior to when the radiators were filled with ammonia and the EATCS were activated in 2006, all the radiator jumper

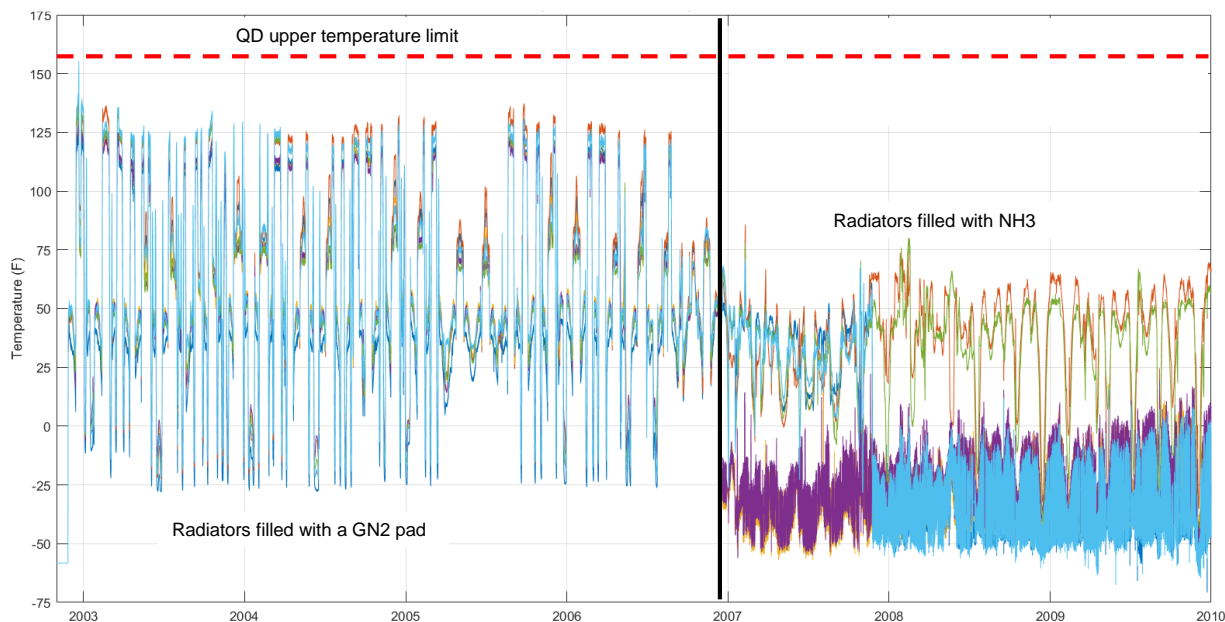
Figure 4. Temperatures from each of the P1 EATCS radiators. Radiators were filled with GN2 until Mid 2006 then filled with ammonia and activated.

QDs were exposed to temperatures higher than operating temperatures for a short period of time as shown in the figure 4. However, the temperatures did not exceed the QD upper temperature limit of 155 Deg F (68 Deg C), and was not expected to cause any damage.

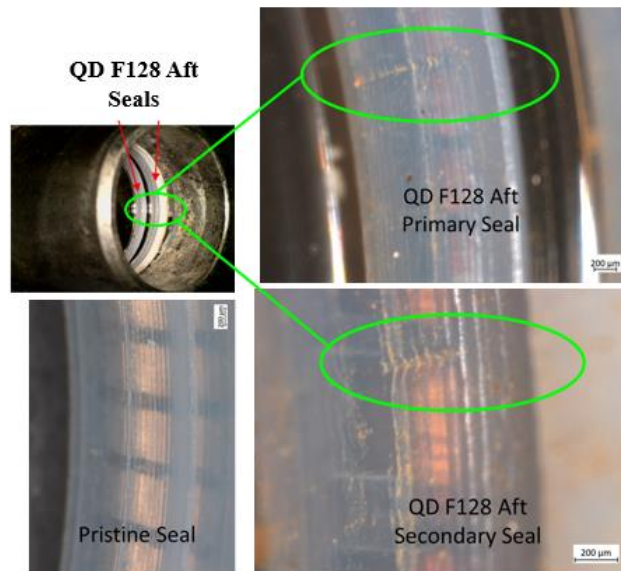
There are female QDs on the radiator return jumpers. QD F140 connects to the system and QD F128 connects to the radiator as shown in figure 1. There are primary and secondary seals located on the forward and aft end of each QD as shown in figure 6 and 5, and the calibrated leak test showed the highest leakage near the aft seals on QD F128¹. After the QD was disassembled, stereo microscopic images found what appeared to be probable installation defect, or kink, on both aft seals on QD F128 as shown in figure 5. The defect goes across the seal in the direction that would allow ammonia to leak to the outside environment. A pristine seal would not have this defect as shown in figure 5, and this defect was not observed on any of the other seals in QD F128 or F140.

Ammonia would have to breach the primary and secondary aft seals to leak out to space. Since the calibrated leak test during the failure investigation showed the highest leakage coming from the aft seals and defects were found on seals, the failure assessment team concluded that at least one of these two aft seals had to have been performing well at time to pass the leak test prior to launch. The other seal could have been performing well or underperforming, which would be undetectable without disassembling the QD. Therefore, the aft seal defects were likely a contributor to the leak of QD F128.

Figure 5. QD F128 Aft Seals Defect Compared to a pristine Seal (QD).

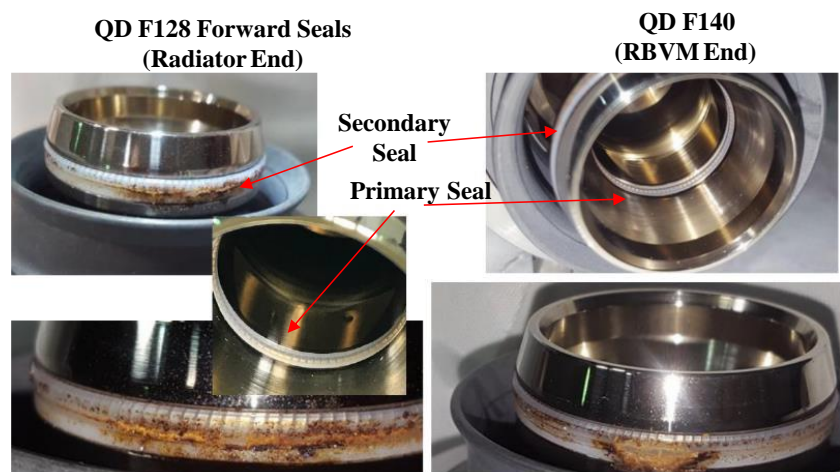
During visual inspections as part of the failure investigation before the QS was disassembled on the ground, brown NVR¹ was found on the secondary forward seals on both QD F128 and F140 as shown in figure 6. Chemical evaluations determined the amount was consistent with what is allowed in the ammonia per requirements¹. Seal leakage over time can deposit NVR on the surfaces on and downstream the seal when exposed to vacuum. As ammonia leaks to space, the NVR would deposit on the cold surfaces as the ammonia vaporizes when exposed to vacuum. Testing have shown that NVR will adhere to cold surfaces, and the radiator return QDs are exposed to -40 to 0 Deg F (40 to -18 Deg C) while in service on-orbit..

NVR deposits might not necessarily impact seal performance but could cause problems for valve cycling (mate/demate). It is expected that these NVR may also reside on the sealing surfaces on the male QDs on-orbit that mate with QD F128 and F140, and could cause problems securing a proper seal when they are mated. Theoretically, soaking the male QD with ammonia could dissolve the NVR and clean the seal surfaces. However, this process would have to be performed during the EVA that will install the refurbished jumpers in March 2022 since the jumpers need to be in place to send ammonia to the male QDs.

Figure 6. Brown NVR shown on the QD F128 and F140 Secondary Aft Seals

To evaluate this, the failure investigation team performed an ammonia immersion test on the leaky QD to determine if the deposits would dissolve back into solution and how long this process would take. The test included soaking the disassembled QD with ammonia for increasing durations, and the final test point included agitation. The results found that the NVR did not readily dissolve back into solution and would take several hours. This is longer than the amount of time available during the EVA to install the refurbished jumpers. Therefore, soaking the male QDs during the EVA would

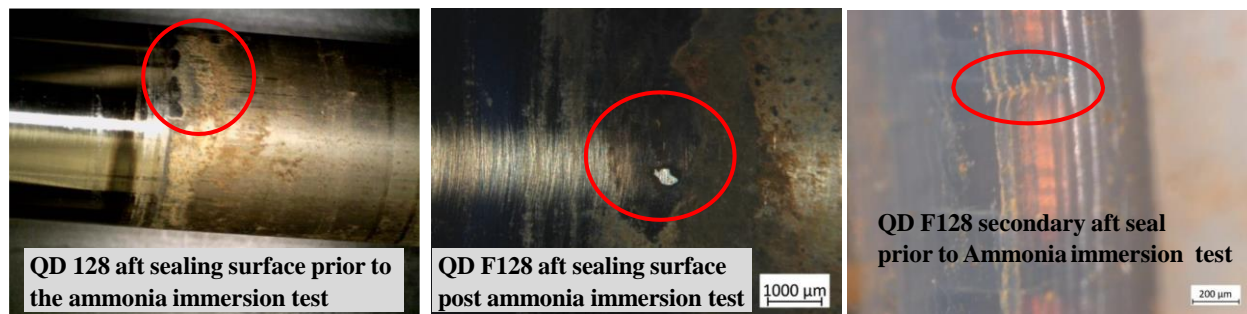
Stereo microscope imagery was performed on the leaky QD following the ammonia immersion test, and nedox plating delamination was found on the sealing surface. This location happens to coincide with the location of defect found on the aft seals on QD F128 as shown in figure 7. Delamination wasn't observed prior to the ammonia immersion as it was hidden under areas with NVR. The consequences of nedox delamination can produce a path for ammonia to leak to space especially if it's located underneath a seal; ammonia would pass under the seal through the delaminated area.

Therefore, this was likely a contributor to the QD leak. Nedox adhesion issues were observed during ground acceptance testing of two similar radiator return QDs and were from the same lot of the leaky QD F128; delamination

Figure 7. QD F128 sealing surface prior (left image) and after (middle image) of the ammonia immersion test. Defect found on the aft seal (right image) coincides with delaminated area (middle image)

was not observed on the ground on QD F128. The lot includes all the radiator return jumper QDs currently on-orbit and on the five spares on the ground. In 2000, NASA M&P led an evaluation of the issue with the vendor, Parker Symetrics, and determined that the likely cause of the delamination was due to contamination of surfaces on a few components during plating.

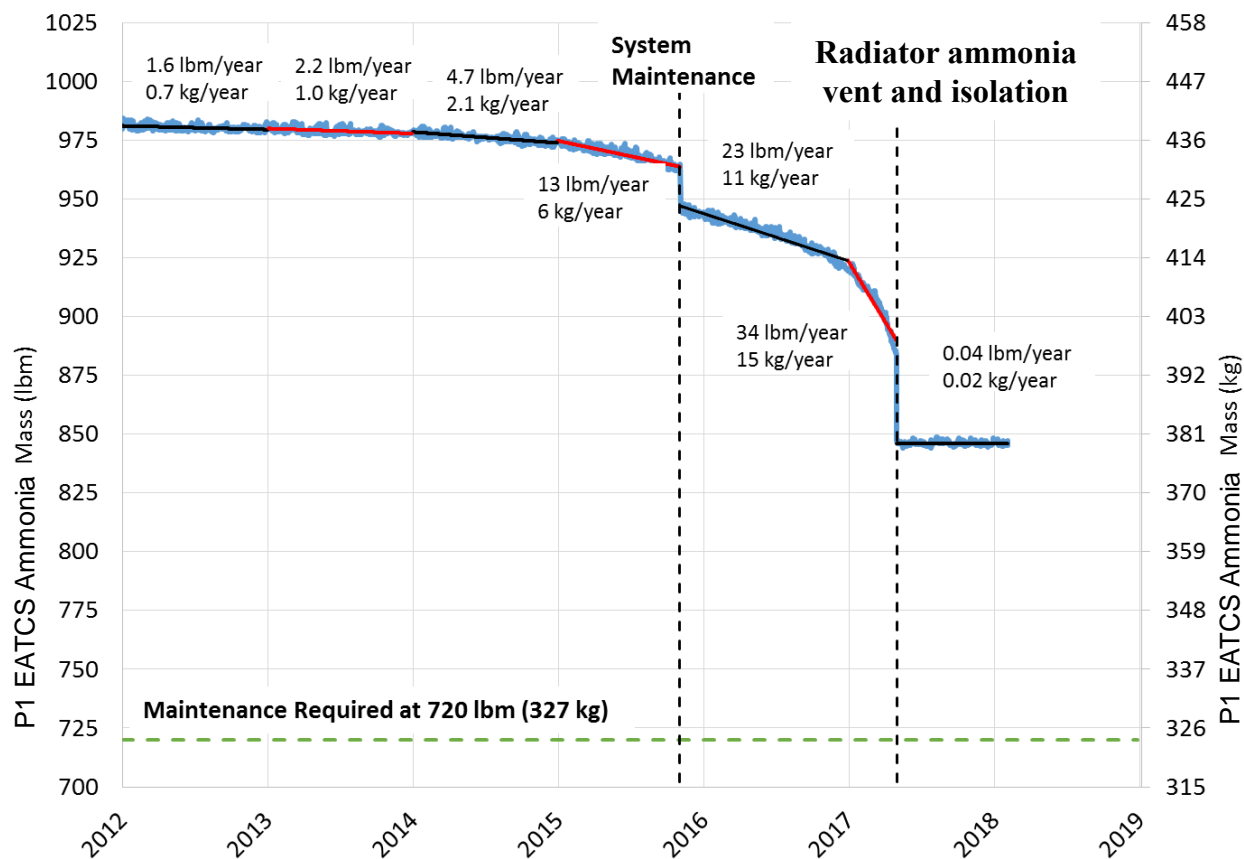
The nominal on-orbit operating temperature of the ammonia flowing through the all the radiator return jumper QD range from -40 to 0 Deg F (40 to -18 Deg C). Though this is well with the requirements of -100 and 155 Deg F (-73 and 68 Deg C), thermal cycling of this magnitude could aggravate the nedox delamination found on QD F128. Thus, cause the delaminated area to grow and leak more ammonia over time. This is likely why the P1 EATCS ammonia leak accelerated while the leaky QD F128 was in service before it was stopped in 2017 as shown in figure 8.

Figure 8. P1 EATCS Calculated Ammonia Mass and leak rates from 2012 to 2018.
